FINAL REPORT
CDRL A030
WETLANDS MITIGATION FOR LANDFILL 3
AT
KESLER AFB, MISSISSIPPI

**FINAL REPORT
CDRL A030
WETLANDS MITIGATION FOR LANDFILL 3
AT
KEESLER AFB, MISSISSIPPI**

**Contract No. F41624-94-D-8106
Delivery Order No. 0089**

**IT Corporation Project No. 920568
Revision No. 0**

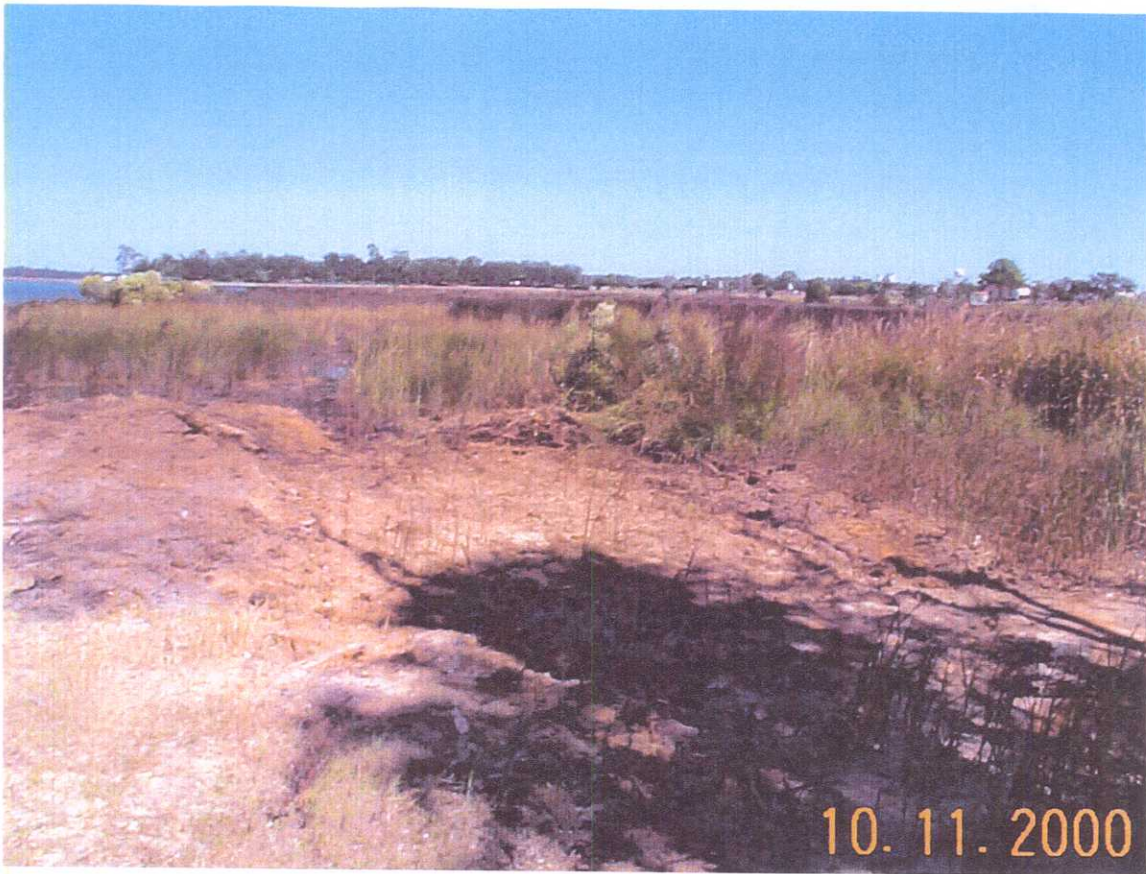
Rework of Site A

Mary Anderson and IT Field Superintendent, Norman Honea with his crew meet on October 10, 2000 to complete the rework of the mitigation area. October 11, 2000 IT removed the cattails in an area designated as Site A adjacent to and east of the road to the mitigation area. Site A was excavated and the material was used to build mounds in the low areas at the end of the road to the mitigation area where the water level at high tide was above that necessary to support the plants. IT graded the excavated area of Site A and replanted fifty (50) stems of *Typha* (cattail) and eighteen (18) clumps (180 stems) of Black Needle Rush plants. IT created Sixty six (66) mounds and planted an average of two clumps of Black Needle Rush plants per mound for an additional one hundred and thirty two (132) plants (1320 stems) in the areas that were low. Another 115 plants (approximately 1150 stems) were scattered throughout the mitigation area. Because the tide was low IT was able to create hummocks in the deeper

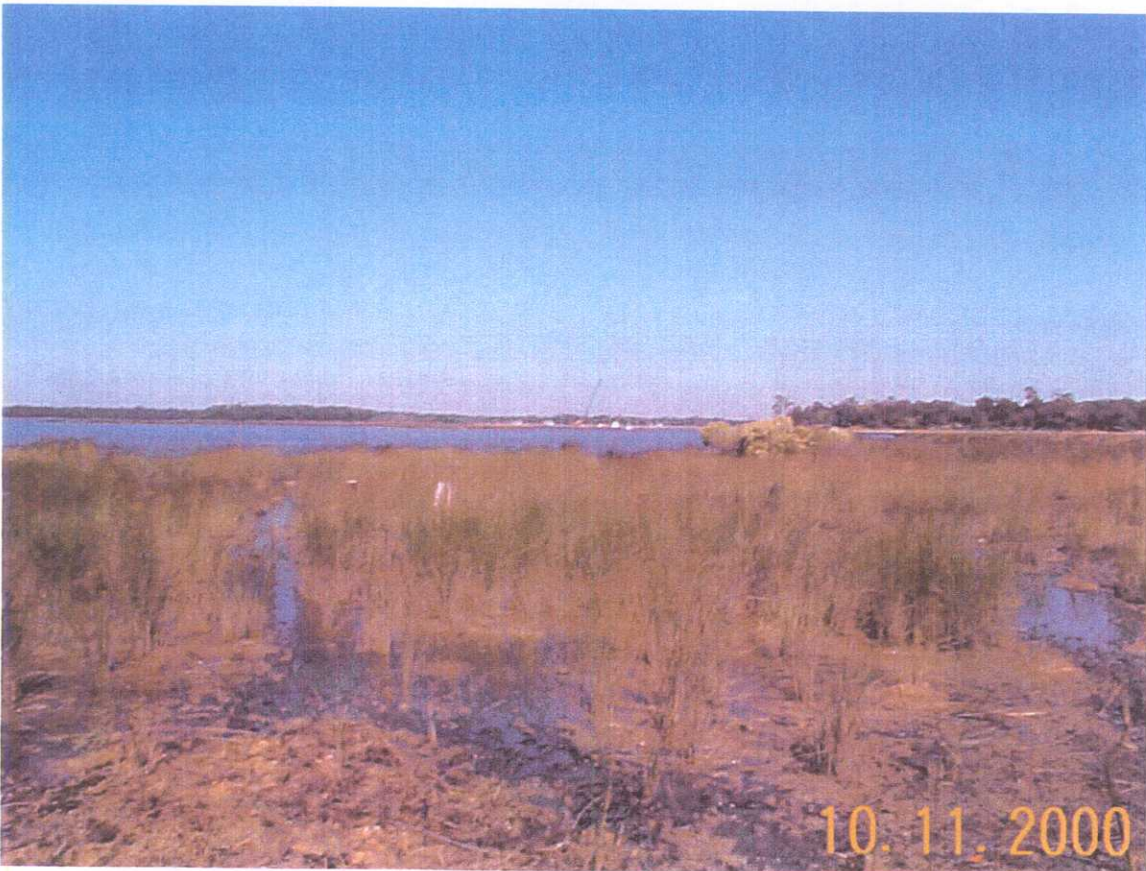
Rework of the mitigation area new mounds and plants

open water areas out past the pilings by carrying pails of sandy soil to the open areas and dumping it to form mounds. These areas were also planted with Black Needle Rush. The donor plants were removed from the marsh area directly adjacent to the mitigation area to the east side of the site.

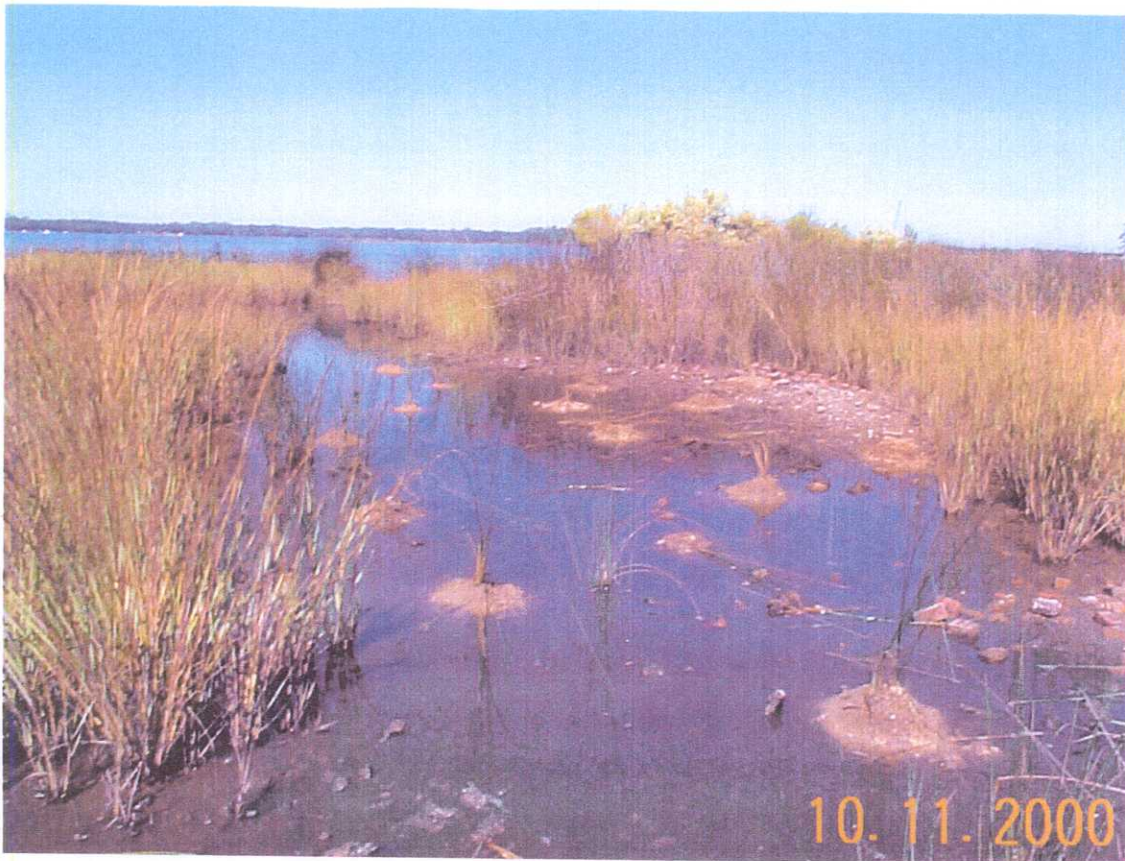
Rework of the mitigation area new mounds and plants

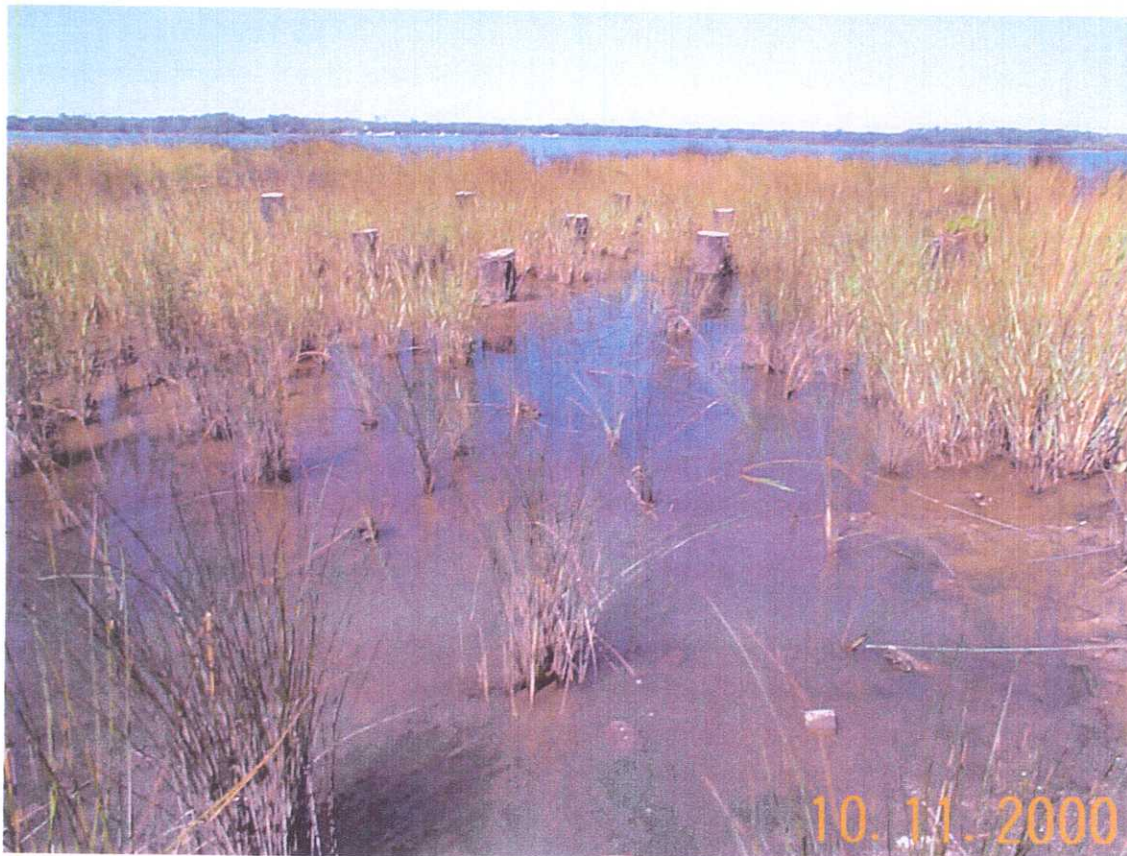
Rework of the mitigation area showing new plants
